S 22-81

Symposium 22-81 Stockholm 1981

REPORT OF FAILURES DUE TO ICE, WIND AND LARGE BIRDS EXPERIENCED ON THE 420 kV LINES OF TURKEY

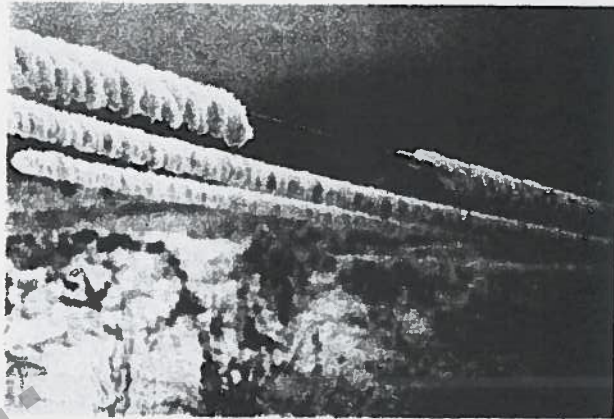
Fig. 3 - Typical ice formation on Rail conductors, Gökçekaya - Seyitömer line.

The ice sheets shown in Figs 3 and 4 cause a vertical overload of 3.5 to 6 times the specified ultimate tower resistances to ice overload; the surface exposed to wind is about 8 times greater. It is obvious that the design loads are exceeded by far and towers are liable to collapse owing to vertical, transversal, and also to longitudinal overload due to ice imbalance.

The only practical remedy against such severe rime-icing is the use of a single large-diameter conductor, instead of twin or triplet bundles, in order to reduce the ice and wind overloads to about one half or one third, respectively. This solution has already been applied in other countries, and is being applied in Turkey on the Bosphorous 420 kV crossing and on the critical portions of the new lines.

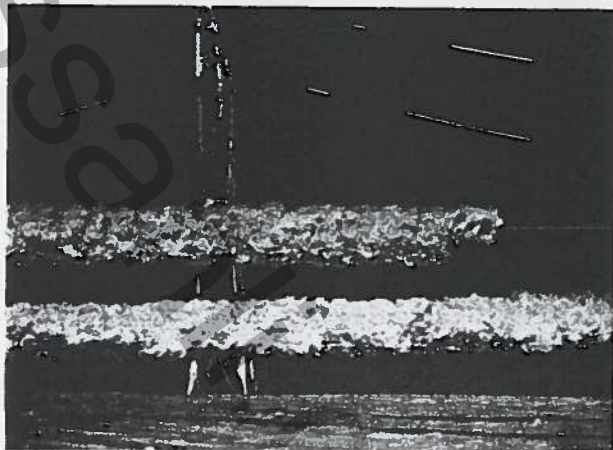
In the case of Fig. 4, the average diameter of the ice sheet

Fig. 4 - Typical ice formation on Rail Conductors, Keban - Kayseri line.

was 23 cm and density was 0.4 gr/cm³, with a resulting average ice overload of 16.4 kg per meter of cable. On one occasion a line repair team reported an ice sheet 45 cm in diameter!

It can be seen from Fig. 4 that the conductors of the second line (in the background) are not covered with ice. This is explained by the fact that the line was carrying a current of about 750 A.

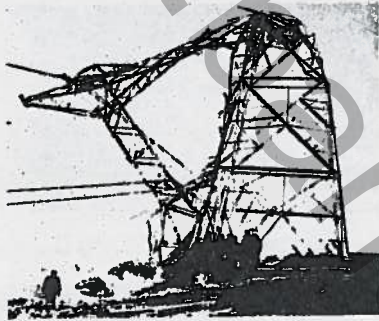
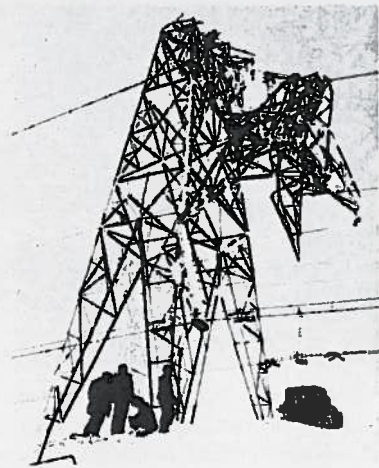
Analysis of the incidents shows that in some cases ice formation occurred only in very few spans, initially causing the collapse of one tower, due to vertical overload combined with transversal wind load. Several other tower then collapsed lengthwise, one by one, due to the longitudinal cascading effect. Sometimes the disaster stopped only at the first anchor tower. Fig. 5 shows examples of towers of the same type which collapsed in a winter incident transversewise and lengthwise, respectively.

Fig. 5 - Collapsed towers, transversewise and lengthwise, on the Keban - Kayseri southern line.

Measures adopted to strengthen the damaged portions of the lines are those usually taken: reduction of spans by inserting additional towers; use of stronger towers of new design; change of line route or use of single conductors instead of bundles, if exceedingly heavy ice formation occurred on a long portion of line exposed to wind. In addition, a new line, about 80 km long,

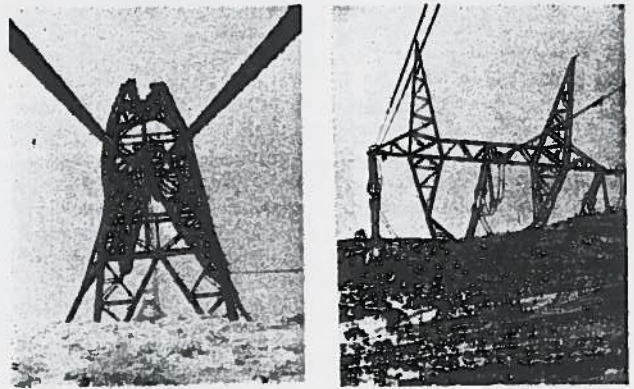
In a couple of incidents, severe rime-ice (see Figs. 3-4) built up continuously on several kilometres of line, when a strong wind was blowing. On one occasion 36 towers were destroyed, including an anchor tower. Fig. 6 refers to the latter disaster.

In the winter incidents, a large number of towers collapsed at the waist, where the delta shaped upper part is connected.

Fig. 6 - Collapsed towers on the Gökçekaya - Seyitömer line. Right: anchor tower; left: suspension tower.

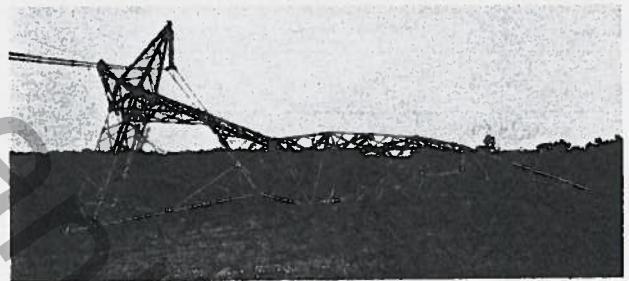
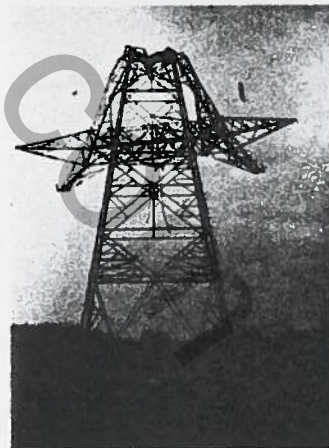
In a summer incident, 17 towers were destroyed, not far from Istanbul due to what was probably an exceptionally intense whirlwind, near the sea. In the strip where it passed, centuries-

A few towers which were directly struck by the wind collapsed transversewise, entirely from their base, as Fig. 7 (above) shows. Many other towers collapsed due to longitudinal pull and dynamic forces; usually this lengthwise collapse occurred at the tower waist, as shown in Fig. 7 (below).

Fig. 7 - Collapsed towers on the Istanbul - Gökçekaya line in a summer incident. Above: transversewise; below: lengthwise.

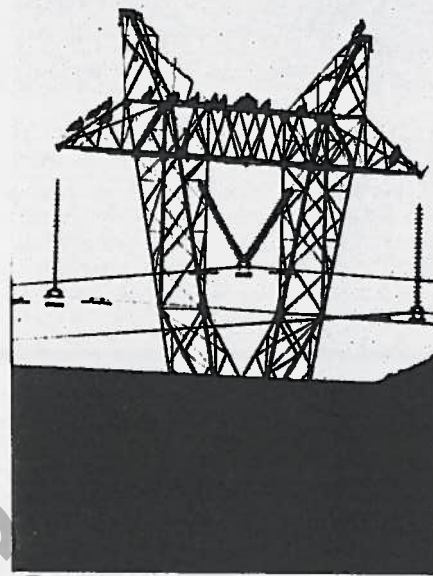
Fig. 8 is a photo taken early in the morning in an area with rocky terrain; it shows an unusually large number of birds.

Fig. 8 - Early morning photograph of egyptian vultures.

- The vultures perch more frequently on the central part of the crossarm. i.e. over the "V" strings, because this portion is horizontal and more comfortable. Small antiperching devices had in fact been installed from the beginning over the outside phases, but this did not prove to be the reason why faults did not occur, because birds could perch nearby (see Fig. 8).

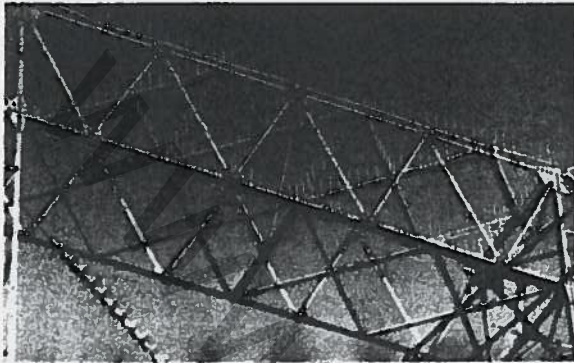
Fig. 9 - Antiperching spikes in the upper face of tower crossarm.

Each steel member of the upper face of the crossarm is covered by a row of vertical steel spikes, as shown in Fig. 9. The spikes are made of 5 mm diameter steel rod and are 20 cm long, with a sharpened tip. Distance between spikes is 10 cm.

Weight is 25 to 35 kg per crossarm. With this solution birds perch for no longer than 10-20 minutes and thus become harmless.
