S 22-81

Symposium 22-81 Stockholm 1981

REPORT OF FAILURES DUE TO ICE, WIND AND LARGE BIRDS EXPERIENCED ON THE 420 kV LINES OF TURKEY

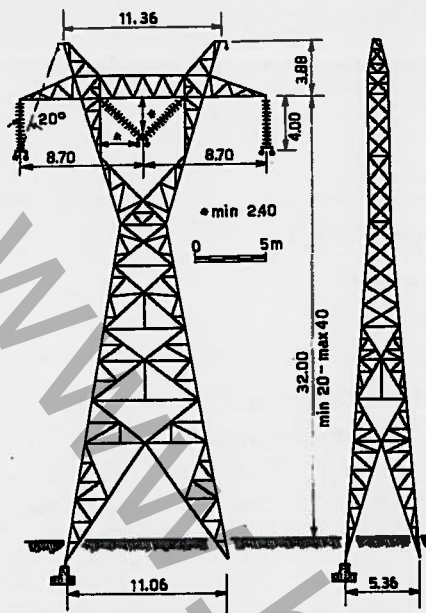
Fig. 2 - Outline of normal suspension tower type 4A1.

It is believed that telescoping of conductors may have been made worse by the non-symmetrical suspension of the three phases ("V" and "I" strings, see Fig. 2), and also by the large sag and relatively low weight of conductor Rail, that contains a very small amount of steel.

- The air clearance between live parts and the lower face of the crossarm is about 2.4 m in the case of "V" strings (see Fig. 2). If this distance is to a great extent shunted by bird droppings, flashover may occur at normal operating voltage. The outside phases have a vertical air clearance of about 4 m from the tower crossarm, and thus partial shunting by bird dropping should not lead to flashover. The same situation holds good for the tension strings.
